ICT for smart evaluation of vernacular architecture in a stilt-house village

Abstract: Vernacular architecture typologies, such as wooden stilt-houses, have been threatened by the vulnerability to conservation status degradation. This problem is not an exception in Portugal, where the few remaining examples have been neglected, with the disappearance or abandonment of almost all buildings, damaging architectural and urban spatial features. This legacy is rapidly disappearing, weakening the European cultural map.

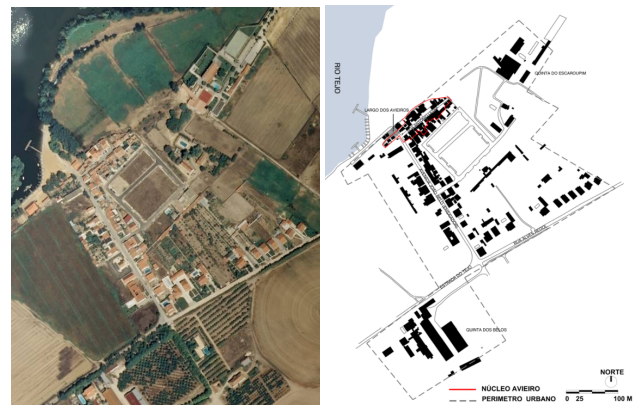
Figure 3: Urban morphology of vernacular village of Escaroupim (IGP, 2007; Almeida, 2015).

ture, and is organized in two alignments of buildings (Figure 3 and 4).

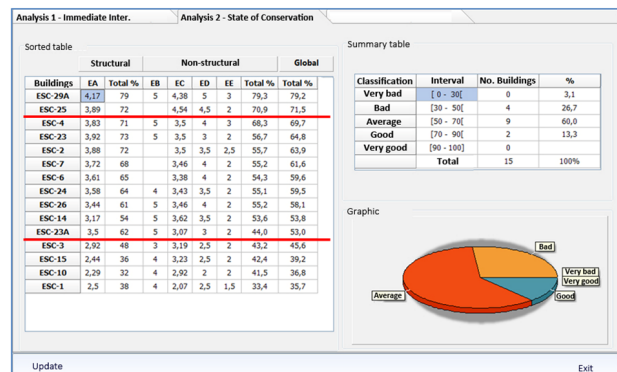
Figure 5: ICT platform application for evaluation of status of wooden stilt-houses conservation, in Escaroupim.

Regarding the status of buildings conservation (Figure 5), the results show that more than a half (60%) of the vernacular houses, including five belonging to the typology of stilt-houses (corresponding to buildings no. 2, no. 4, no. 23, no. 23a and no. 24), and four belonging to the typology of single-story houses (which are buildings no. 6, no. 7, no. 14 and no. 26) are in the ‘average condition’ level.

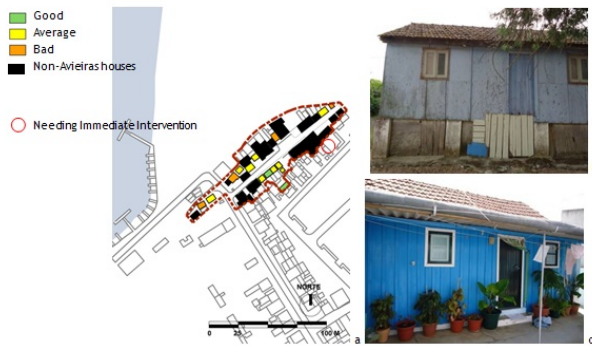
Figure 6: ICT platform application for evaluation of status of wooden stilt-houses conservation, in Escaroupim: a. vernacular stilt-house village of Escaroupim; b. the worst case of status of building conservation (corresponding to the wooden stilt-house no. 1); c. the best case of status of building conservation (the single-story house no. 29a).

The other buildings are classified in the ‘bad condition’ level (26,7%) including three of stilt-houses typology (no. 1, no. 3 and no. 10), and one belonging to single-story house typology (no. 15), located in the west alignment of the village (Figure 6a). There are some buildings (13,3% of them) in ‘good condition’ level including two single-story houses (no. 29a and no. 25), which are located on the east alignment of the village.

The wooden stilt-house (Figure 6b) in worst condition, is the building identified by no. 1, degraded not only in coatings and finishes (EC), but also in other non-structural elements (ED).

On the other hand, from the ICT platform application to the Escaroupim wooden stilt-houses, it is possible to conclude that four buildings, which represent 27% of the total, require deep rehabilitation actions, due to their degradation (which is the case of buildings no. 1, no. 3, no. 10 and no. 15).

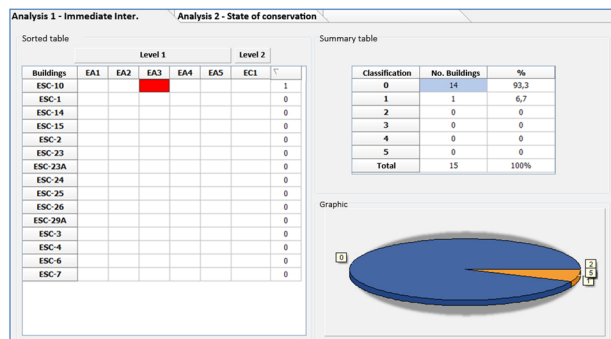
Figure 7: ICT platform application for evaluation of status of wooden stilt-houses conservation, in Escaroupim: the identification of needs for immediate intervention in vernacular wooden stilt-houses.

Finally, this smart method shows that the wooden stilt-house identified by no. 10, which is an empty building, has the warning indicator active, related to structural horizontal elements (Figure 7). Therefore, this is the most problematic case, needing immediate intervention (Figure 8). In this village, there are no houses in 'very bad condition' level in terms of status of buildings conservation.

The need for immediate intervention in the building is the result of very serious anomalies that are putting in danger the safety of people or that have no safety guaranties of building use conditions (as shown in Figure 6).

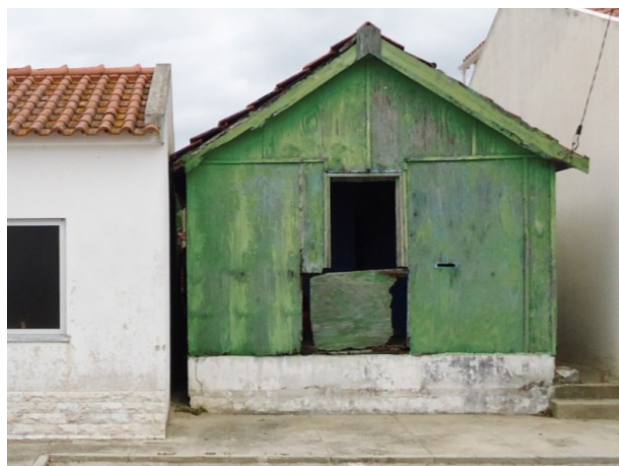
Figure 8: ICT platform application for evaluation of status of wooden stilt-houses conservation in Escaroupim: the wooden stilt-house identified by no. 10, is the most problematic case.
