IMPACT STRENGTH OF CARBON/EPOXY LAMINATES WITH HOLES

ABSTRACT

The effect of non-perpendicular holes on the impact strength of carbon fibre/epoxy composite laminates was studied. In order to understand this effect, flexural tests were also performed to evaluate the bending strength. It was possible to conclude that higher angles promote a decrease of the bending loads. In terms of impact tests, higher angles promote a decrease of the maximum impact load, impact bending stiffness and elastic recuperation. An opposite tendency occurs in terms of maximum displacement.

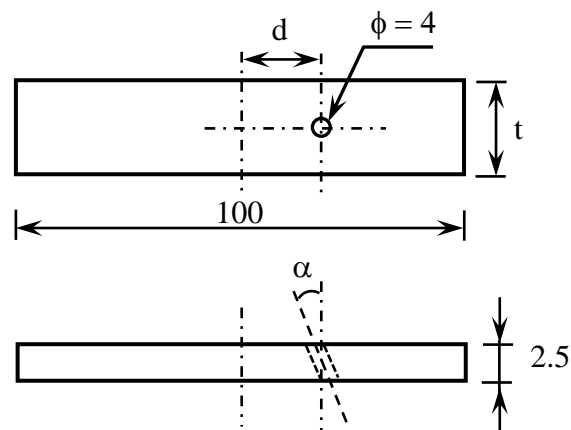
Figure 1. Geometry of the CFRP samples, dimensions in mm ($t = 20$ mm for flexural tests, $t = 100$ mm for impact tests; $d = 10$ mm; $\alpha = 0^\circ, 10^\circ$ and 20°).

Figure 1 shows the geometry of the CFRP specimens used in the flexural and impact tests. These specimens were obtained from the thin plates and the dimensions are, respectively, 100x20x2.5 mm³ and 100x100x2.5 mm³. Angles of 0°, 10° and 20°, with the vertical axis, and diameter of 4 mm were obtained with a special drill for this effect. After drilled, the specimens were evaluated again by C-Scan to verify if any defect was introduced.

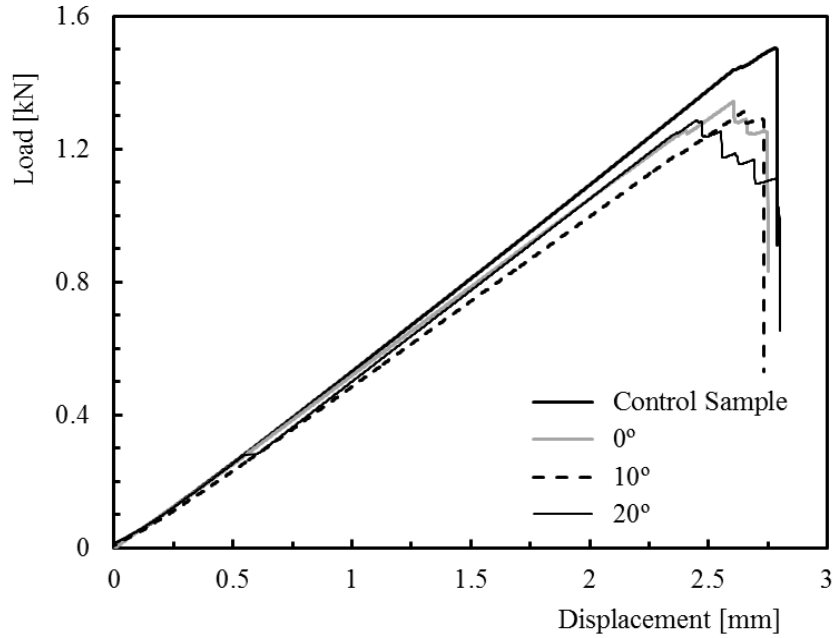
Figure 2. Load-displacement curves for different angles.

Figure 2 shows representative curves of the bending load versus flexural displacement for the angles studied. A nearly brittle behaviour can be observed for all angles, with a linear region up to the maximum load, and a significant drop of the flexural load after peak stress was reached. Figure 3 presents the results in terms of maximum load, where the symbols represent the average

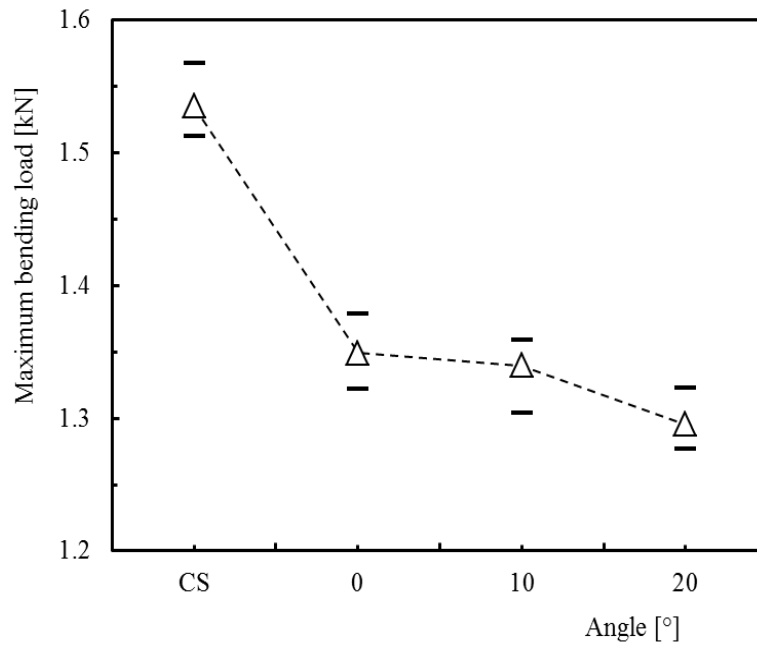
Figure 3. Maximum bending load versus angle of the hole.

values and the bands represent, respectively, the maximum and minimum values obtained from the five tests. For laminates without holes (control samples) an average maximum load of 1535 N was found, and this value tends to decrease with the angle of the hole. For example, when the angle is 0° the average maximum load decreases around 12.1%, comparatively to the control samples, but, when the angle is 20° this value is about 15.6% lower.

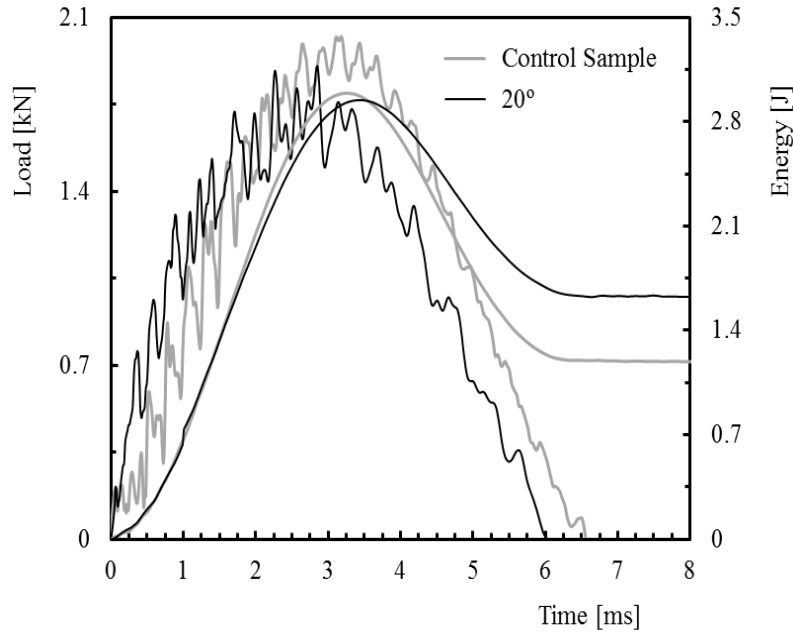
Figure 4. Load-time and energy-time curves for control samples and samples with holes with angles of 20°.

Given that for the angles studied the difference of the average maximum load between the 0° and 10° angle was around 0.6%, the last one was removed from the study of the impact strength. Figure 4. shows the force-time and energy-time curves, which represent the typical behaviour occurred for all laminates and agree with the bibliography. These curves contain oscillations that are consequence of the vibrations promoted by the samples.

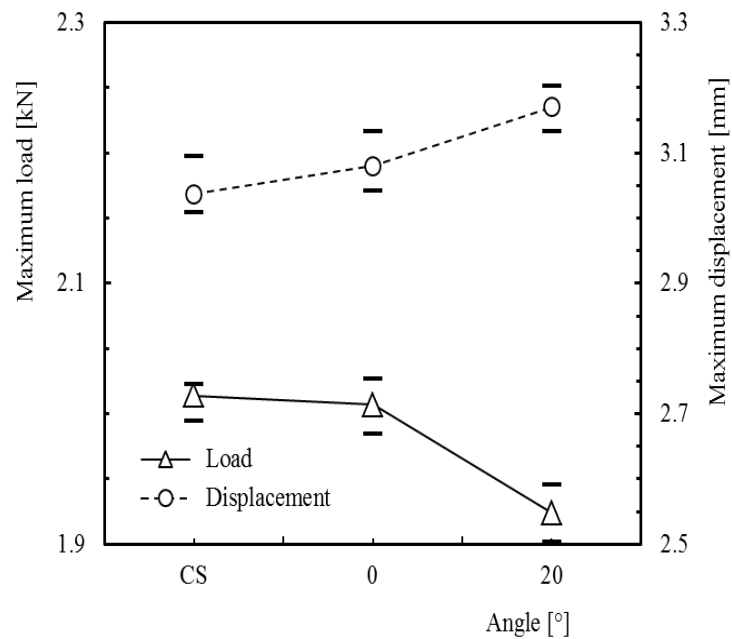
Figure 5. Maximum load and maximum displacement versus angle of the hole with the vertical axis for the impact tests.

Figure 5 shows the results in terms of maximum load and maximum displacement. For the CS an average maximum load of 2014 N was obtained. This value was 2.3% lower for the hole with a 0° angle and 7% lower for the 20° hole. The decrease of the load with an increasing of the angle can be explained by the damage mechanisms presented in Figure 6.

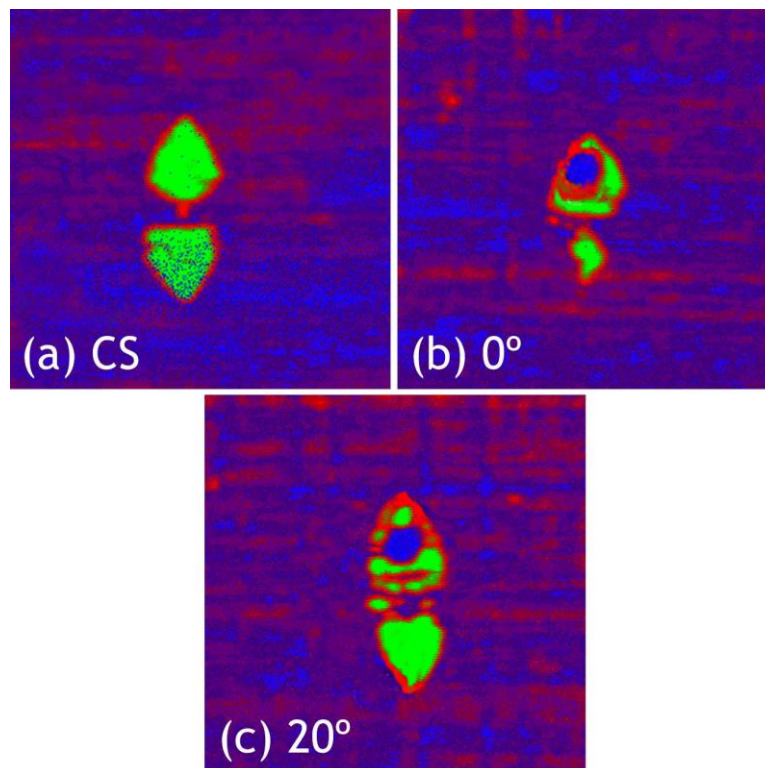
Figure 6. C-scan pictures of the samples: (a) Control Sample; (b) Holes of 0° ; (c) Holes of 20° hole.

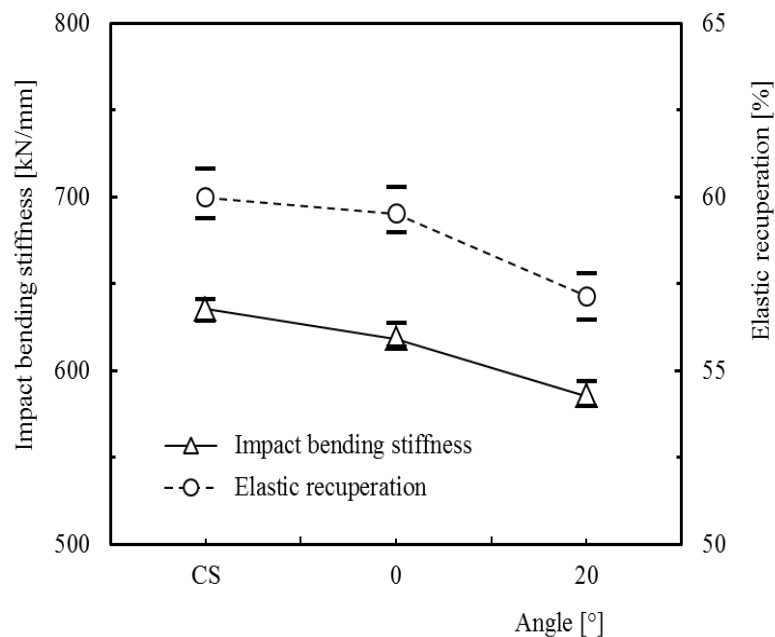
Figure 7. IBS and elastic recuperation versus angle of the hole.

Figure 7 presents the impact bending stiffness (IBS) and the elastic recuperation. As shown, both variables decrease with an increase of the hole angle. For control samples, the average IBS is 635 kN/mm and this value is 2.6% and 7.9% lower for 0° and 20° , respectively. On the other hand, the elastic recuperation for the control samples is about 60%, and a decrease of 0.8% for 0° holes and 4.7% for 20° holes was noted. This decrease in elastic recuperation is necessarily accompanied by an increase in absorbed energy, which agrees with the previous results. Therefore, it is evident the effects of the angle on the impact strength.
